PENICUIK CONSERVATION AREA MANAGEMENT PLAN

INCORPORATING THE MANAGEMENT AND MAINTENANCE PLAN
FOR THE PENICUIK HERITAGE REGENERATION PROJECT AREA

2018

PENICUIK CONSERVATION AREA MANAGEMENT AND --- MAINTENANCE PLAN

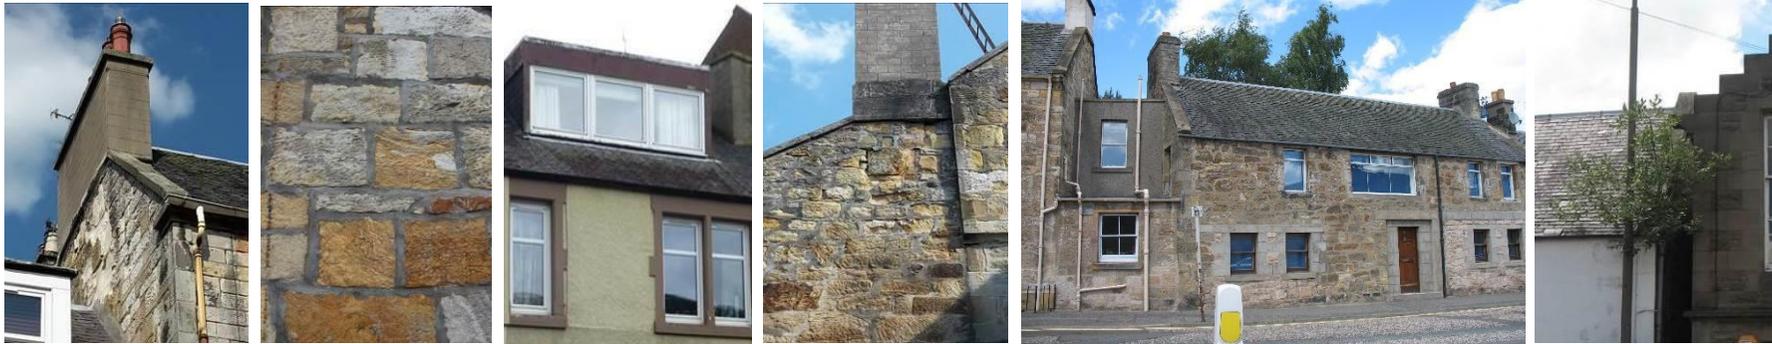
3.4 There are also several examples of restorations which have introduced cement pointing to the mortar bedding of the sandstone masonry which most of the buildings are constructed from. The original construction would have used traditional slaked lime in the mortar bedding of the masonry which allows the material to breathe. Cement retains moisture and water and will cause more rapid decay of sandstone.

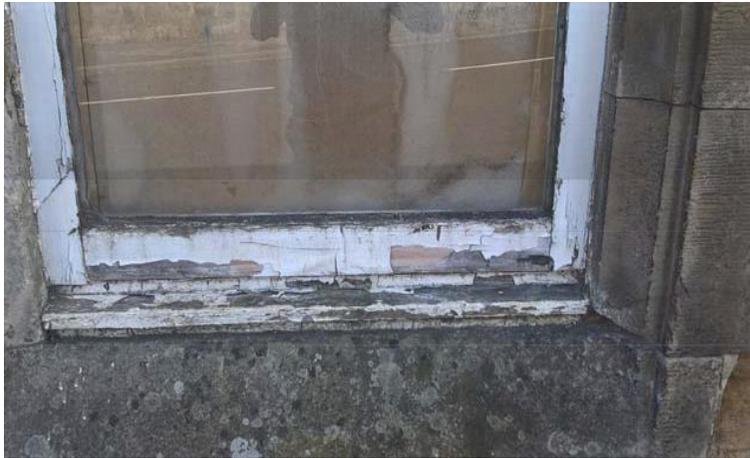
Evidence of lack of maintenance of paintwork on West Street

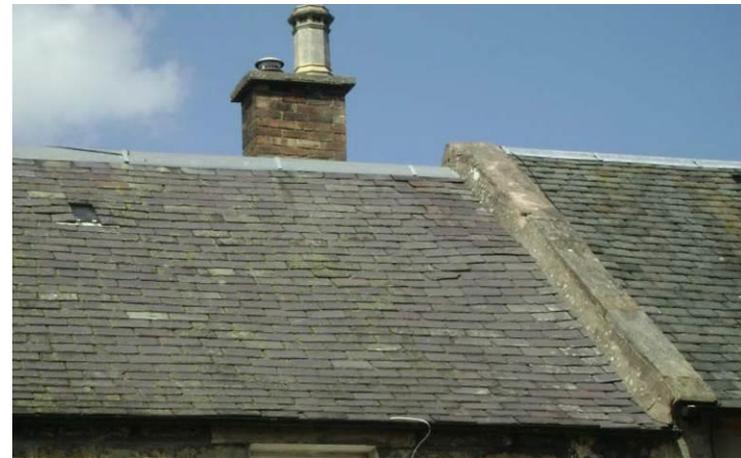
Welsh slate roof showing numerous patch repairs West Street

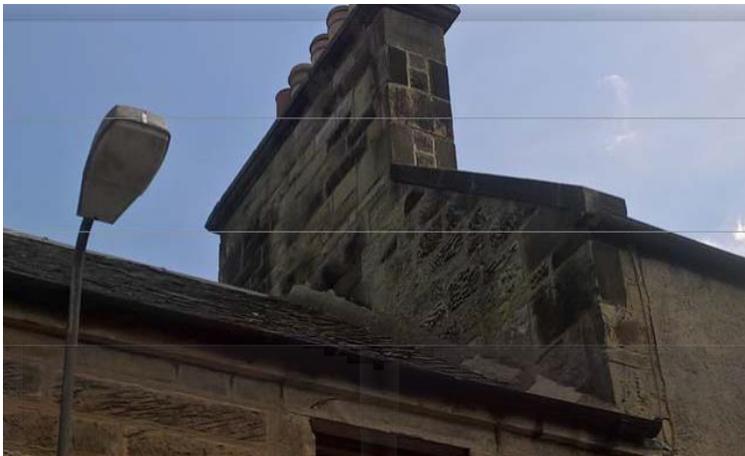
Failed cement fillet at base of gable and junction with slates

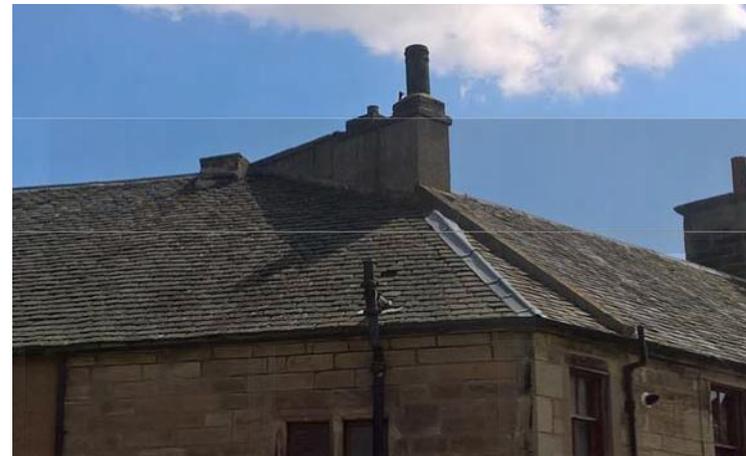
Truncated and cement harled masonry chimney stack

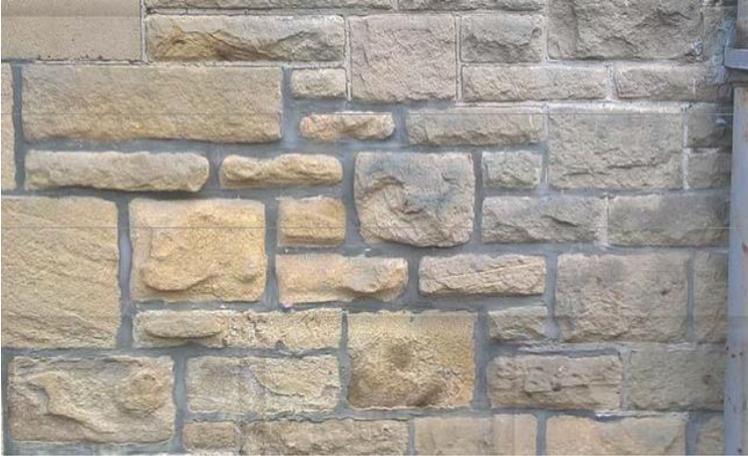
Evidence of recent cement pointing

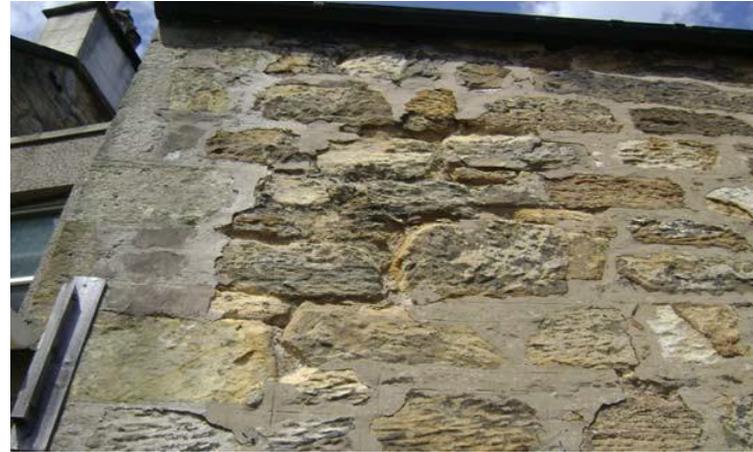
Cement over pointing causing rapid masonry erosion

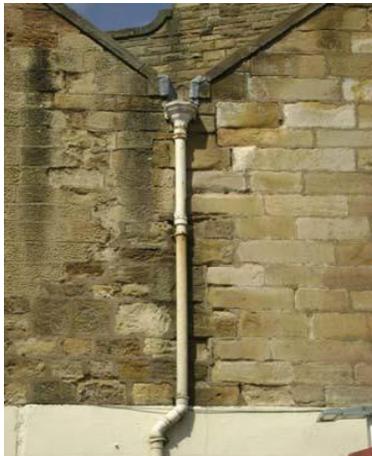
Water damage to masonry

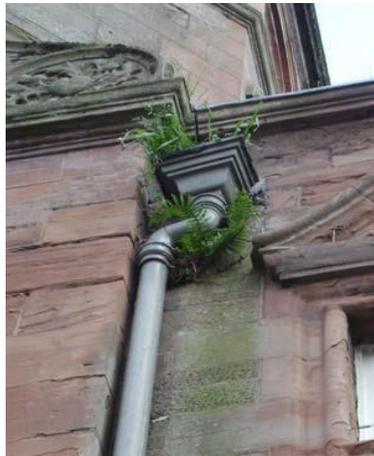
Vegetation growth

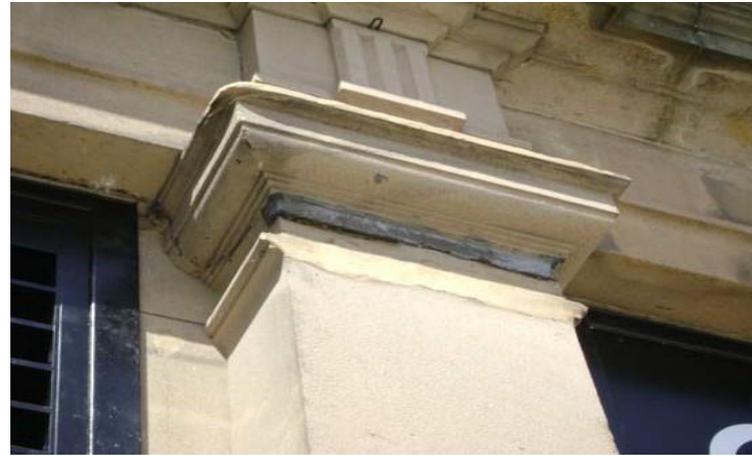
Mouldings below capitals roughly cut off
