PENICUIK CONSERVATION AREA MANAGEMENT PLAN

INCORPORATING THE MANAGEMENT AND MAINTENANCE PLAN
FOR THE PENICUIK TOWNSCAPE HERITAGE PROJECT AREA

2018

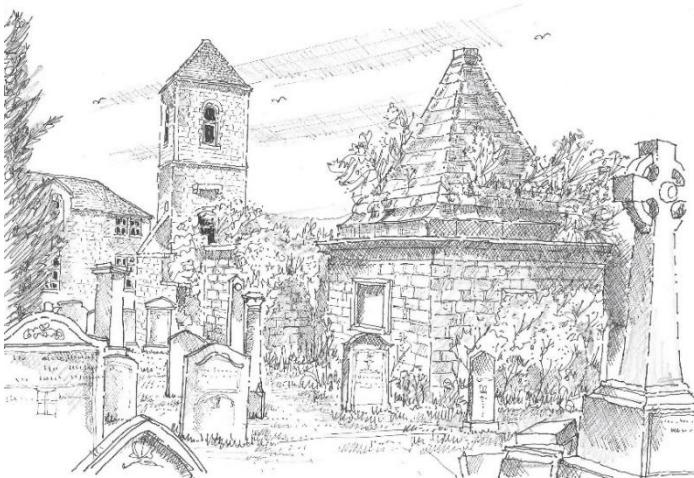
8. Behind St Mungo's church is St Kentigern's church yard which provides a quiet oasis away from the busy street with interesting features such as the Clerk Mausoleum (1684). A chunky family sepulchre in the form of a vaulted pyramid-roofed cube, its broken cherubim, ringed urn-finial lies beside. The mausoleum and St Kentigern's Church tower are in poor repair with vegetation sprouting.

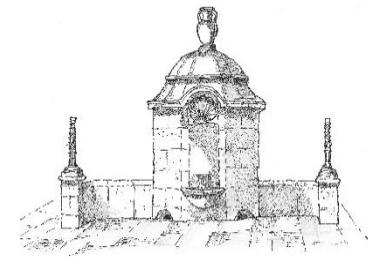
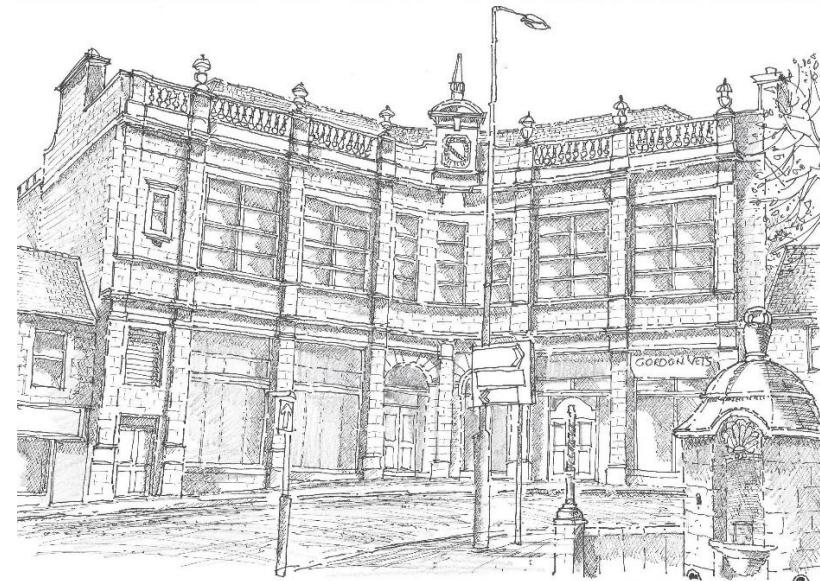
9. The old co-op buildings at 6-10 High Street provide a pleasing sweep around at the bottom of the street, taking the eye into West Street and The Square. This building has a fine bowed shop front with balustrade parapet dated 1905. In front is the restored Cowan Well (1864).

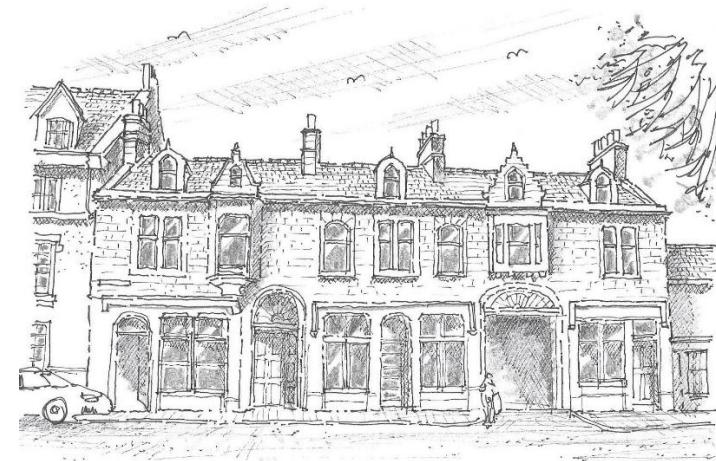
13. At the junction of West Street and The Square is another key building that turns the corner, the baronial former District Council Chambers (1916) with interesting crow stepped gable and dormers, ashlar dressings around door and window openings and coursed rough sandstone with a stone string course at first floor level with scot slate roof and chimneys.

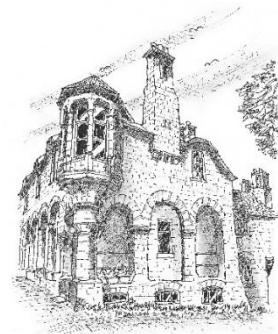
18. Of particular interest is 22-34 Bridge Street designed by the architect FT Pilkington (1860). This block is designed around a courtyard to house single women working for Charles Cowan at Valleyfield paper mill. The architect has emphasised the vertical elements, Romanesque windows project into hipped gables and huge chimneys dominate the roofline. There are some attractive carved stonework details which contrast with the rock-faced masonry.

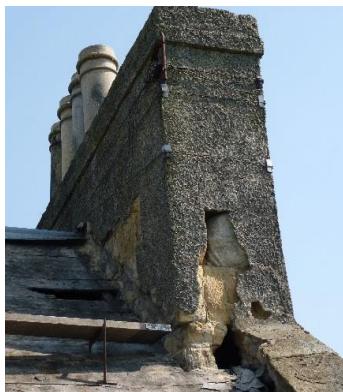
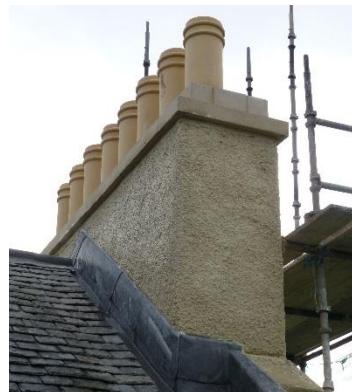
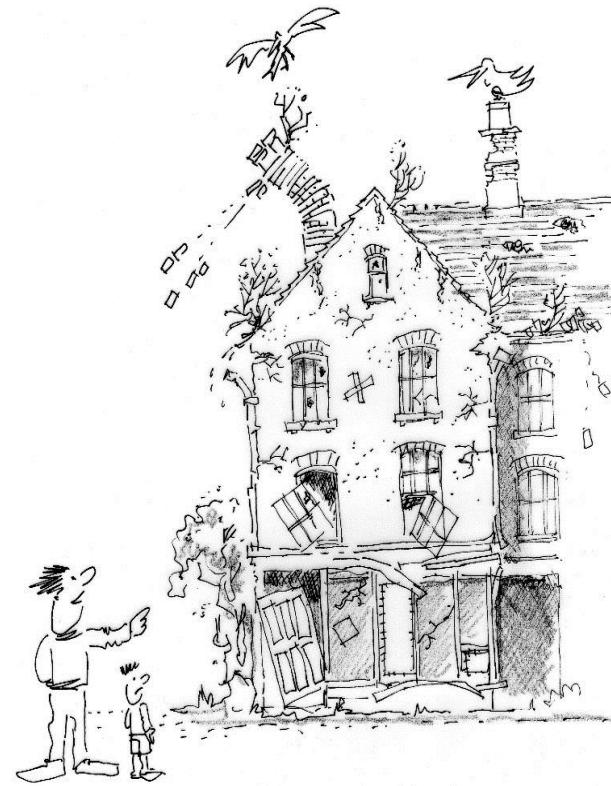
34. Chimney stacks (called 'stalks') are the parts of the building most vulnerable to weathering as they are generally exposed on all faces. Chimney stalks are usually built in fairface rubble masonry but are often rendered with cement where the stone has decayed. The junction between the chimney stalk and roof is a weak point in the roof covering and any deterioration of the lead flashings or cement fillets here should be repaired promptly.

35. Chimney cans (pots) are generally made of clay and set into a stone cope on top of the chimney stalk and haunched with cement. Skews are the stone cappings to the gable walls against which the slate roof abuts. The joint is formed with a concealed lead flashing, or more commonly a cement fillet as on a chimney. Skew stones are bedded and pointed in lime mortar on the sloping top of a gable wall and may be supported at the foot by a shaped stone called a skew putt. The repair of roof leadwork such as copings, flashings, valleys and gutter linings should be designed and installed in accordance with good practice and industry recommendations.

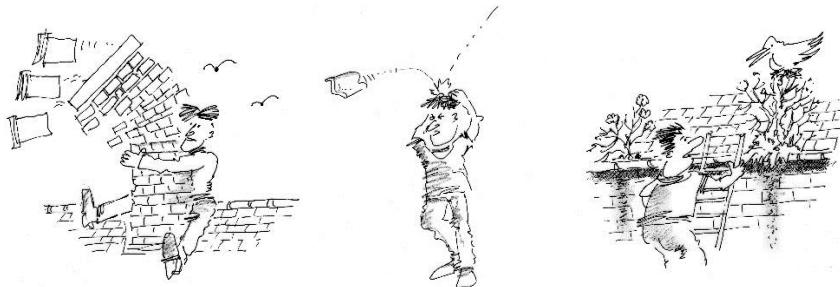
36. Rainwater Goods include rhones (gutters), hoppers, brackets, downpipes and shoes at the foot. Cast iron was traditionally used because of its durability. If properly maintained, these elements have a long life. Cast iron must be painted to prevent deterioration and all joints between the various parts should be watertight. Rhones should be cleaned out annually to remove dirt and leaves. All cast iron should be repainted when the existing coating starts to deteriorate or at 5 yearly intervals (whichever is soonest). Replacing cast iron with other materials such as uPVC or aluminium is not acceptable.

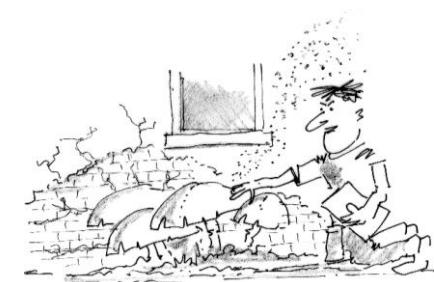
38. Moisture in the base of walls can be reduced by lowering ground levels, improved drainage around the building, replacement of any hard cement mortar with lime mortar and, if none exists, the introduction of underfloor ventilation. Modern injected damp proof courses are of little value in traditional masonry walls of composite constructions as described above.

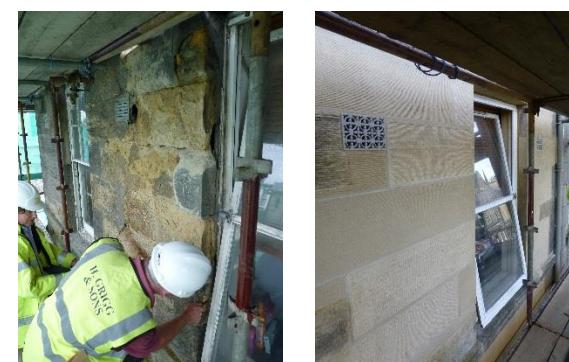
39. Natural stone deteriorates, albeit very slowly, and may require repair or replacement if surface decay becomes significant or structurally damaged. Repairs should only be carried out with matching stone. Patching with cement or other substitutes is not acceptable. Many buildings have been repointed with hard cement mortar which can accelerate the decay and deterioration of the stone blocks. Where repointing is to be carried out, lime mortars should always be used as this will prolong the life of the building. This work should be carried out by skilled tradespeople and should match the materials and style of the original pointing.

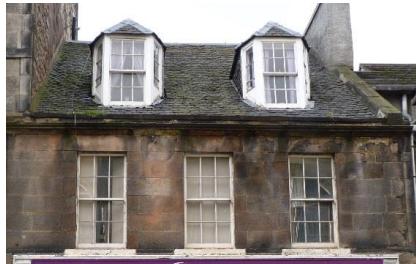
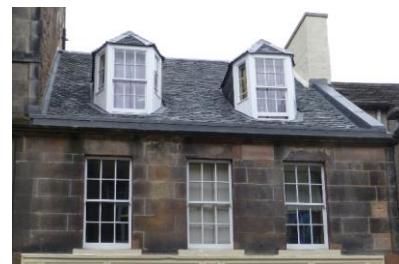
40. Window design and proportion are a key part of a building's character. Replacement of traditional windows with new types and styles. The majority of original windows in the town were either casements or sash. If traditional windows have deteriorated the first recommended course of action is repair. This can be carried out by an experienced joiner. Repairs can be carried out more cheaply than replacement with other styles or materials, and will maintain the original character and fabric of the house. The thermal insulation value of sash windows can be improved with draught stripping or secondary glazing, which must be fitted internally.

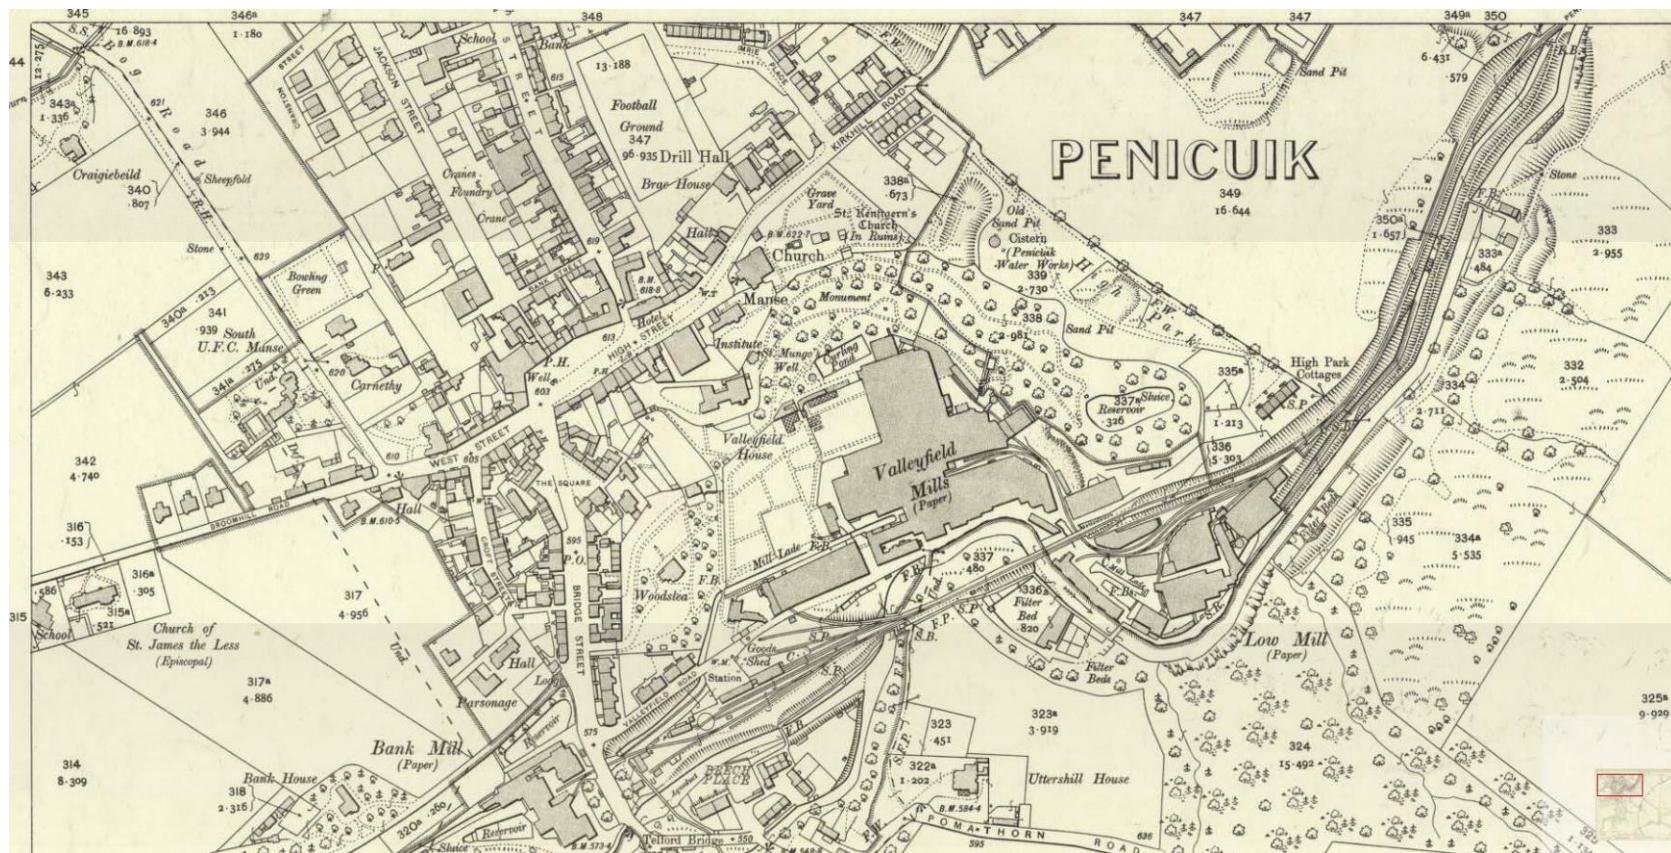
- 2.5 The map which follows shows the dense urban settlement following the main north south toll road immediately adjacent to the major employer and paper making works of the Valleyfield Mill complex. Note the virtually continuous edge of building frontages tightly packed along Bridge Street, West Street, High Street and John Street.

Late 19th Century map of Penicuik town centre

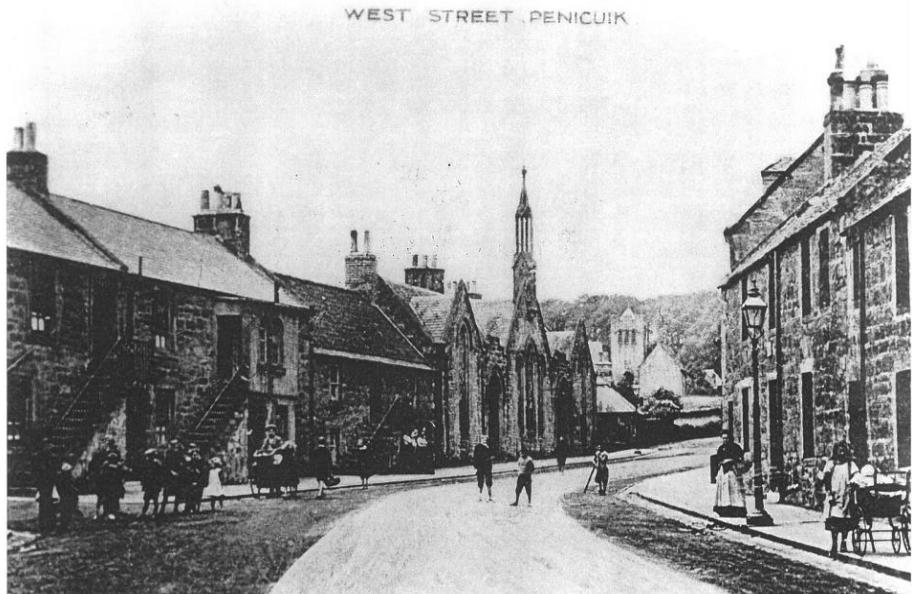
West Street Church with Spire (now South Kirk Hall)

- 3.3 It has been observed that some original historic features on buildings have been lost or deliberately removed such as the West Street church spire (Figure 3) and the “witches hat” turret roof form at 30 Bridge Street (Figure 4). Several chimney stacks have been removed or reduced in height and inappropriately capped. More common across the TH area is the steady erosion of character caused by the substitution of modern fenestration styles and the use of UPVC windows rather than traditional timber sliding sash and case window units. In a similar manner, cast iron guttering and downpipes have been removed and substituted with modern, inferior plastic rainwater systems.

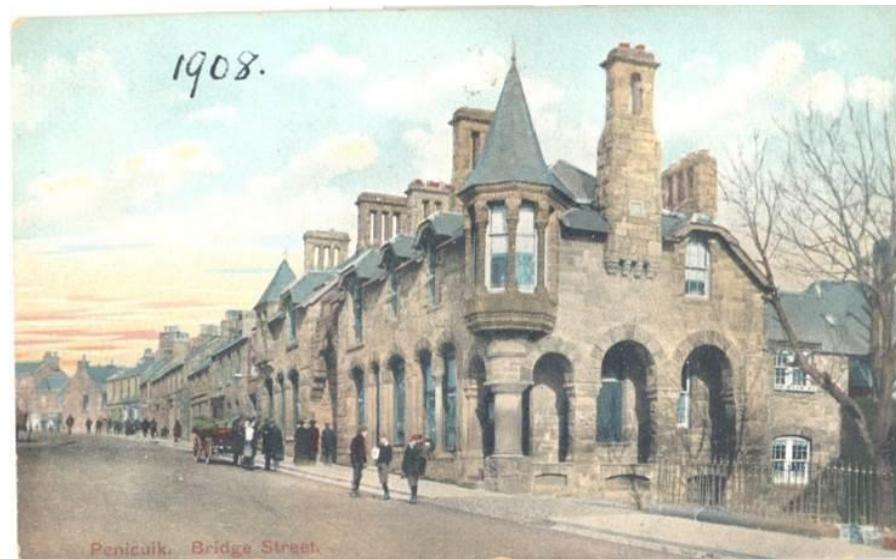
Pilkington Buildings (22-30 Bridge Street) with original turret roof

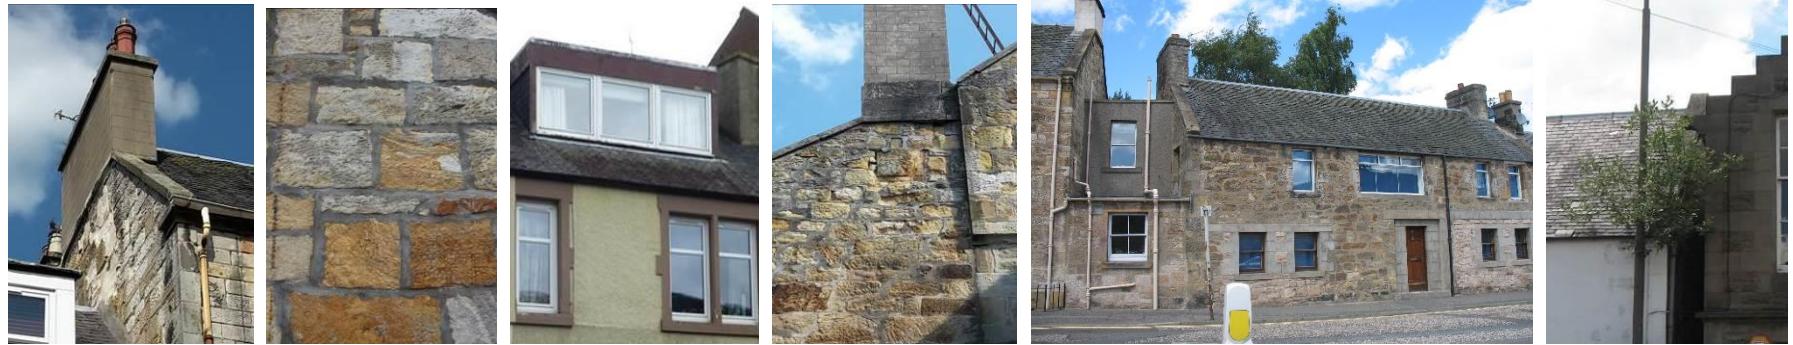
- 3.4 There are also several examples of restorations which have introduced cement pointing to the mortar bedding of the sandstone masonry which most of the buildings are constructed from. The original construction would have used traditional slaked lime in the mortar bedding of the masonry which allows the material to breathe. Cement retains moisture and water and will cause more rapid decay of sandstone.

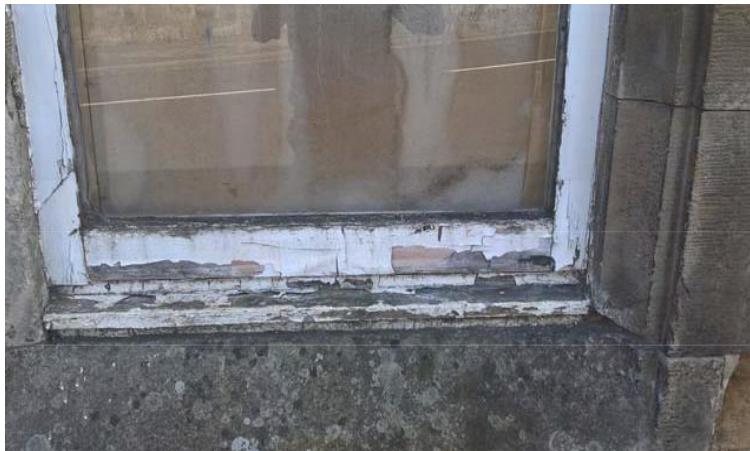
Evidence of lack of maintenance of paintwork on West Street

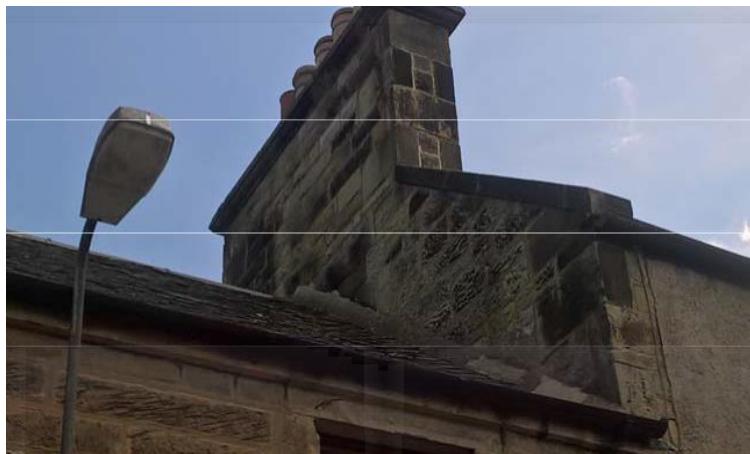
Failed cement fillet at base of gable and junction with slates

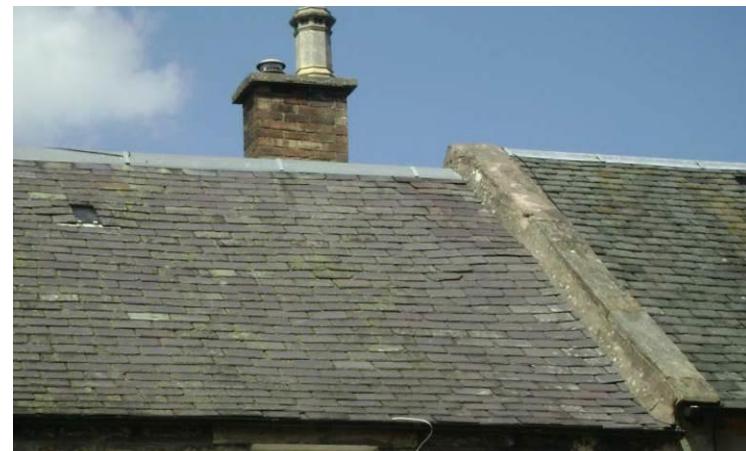
Welsh slate roof showing numerous patch repairs West Street

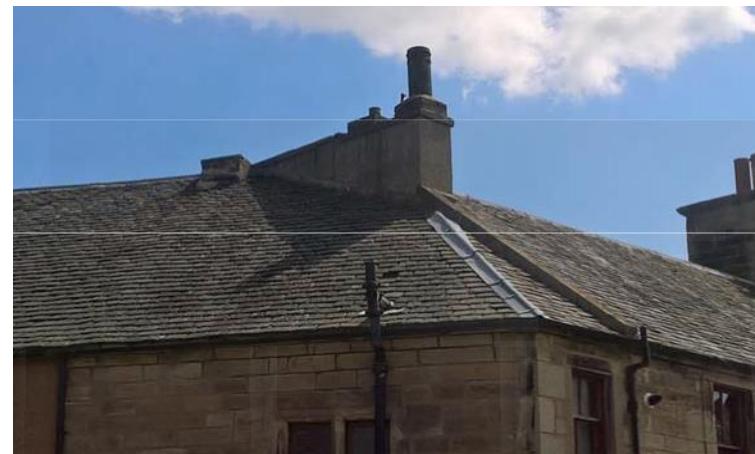
Truncated and cement harled masonry chimney stack

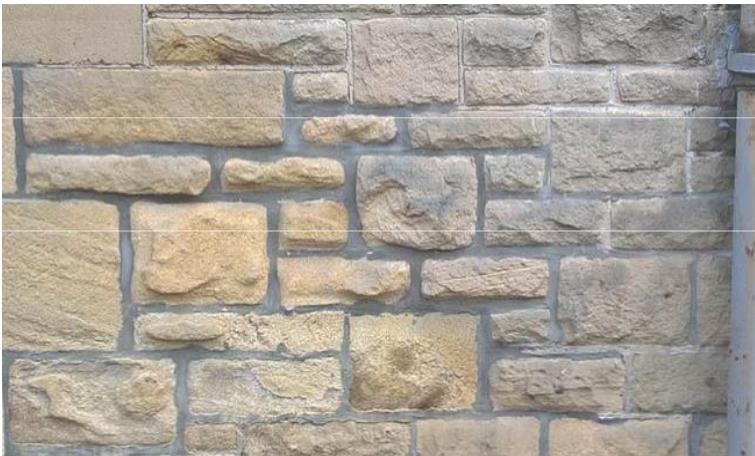
Evidence of recent cement pointing

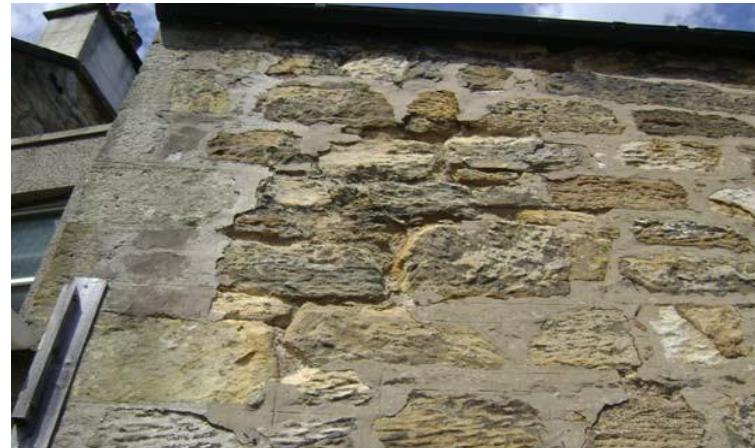
Cement over pointing causing rapid masonry erosion

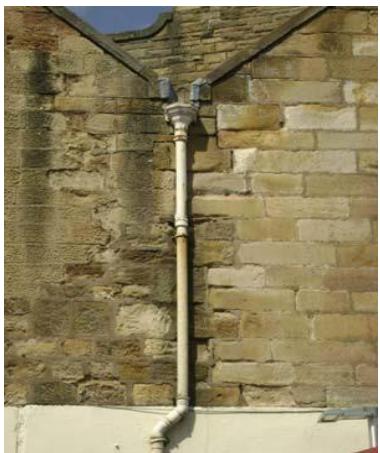
Water damage to masonry

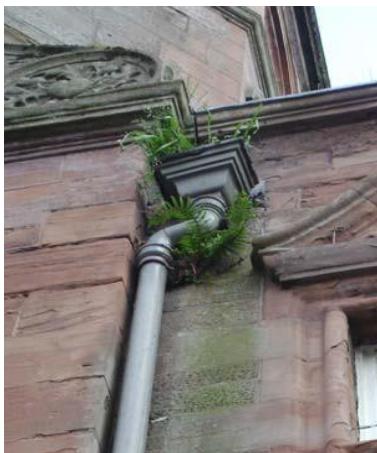
Vegetation growth

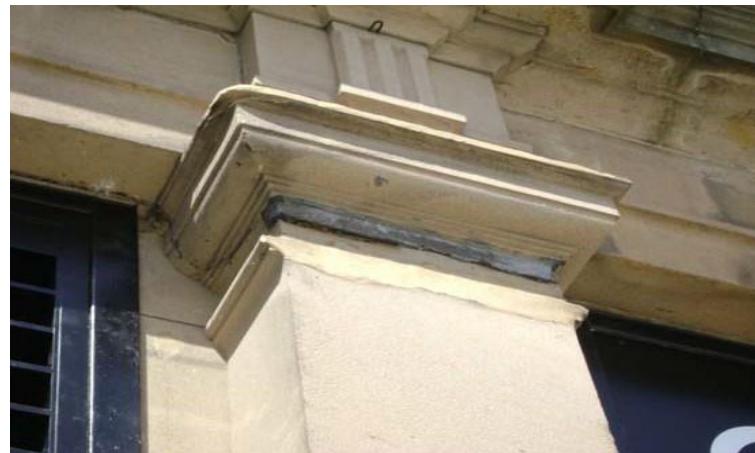
Mouldings below capitals roughly cut off
